239 Inspection Services
9990 Coconut Road
Bonita Springs, FL 34135

HOME INSPECTION REPORT

239 Inspection St
Fort Myers, FL 33908

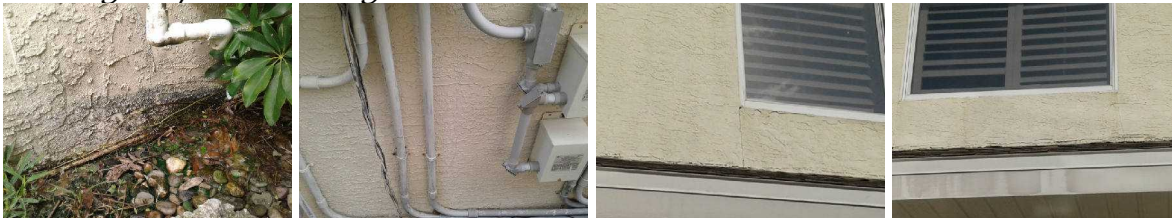
2. Siding: *Stucco - Moisture/organic growth stains. Recommend further review/repair by a qualified licensed tradesperson. Common cracks noted. Suggest sealing and painting as part of a regular home maintenance routine.*

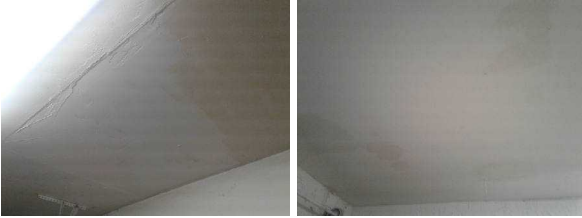
5. Attached Garage Ceiling: *Common cracks noted. Repairs/patching noted. Water stains noted, tested and appear inactive at time of inspection. Recommend reviewing with owners about any repairs that may have been made and/or further review/repair by a qualified licensed tradesperson.*

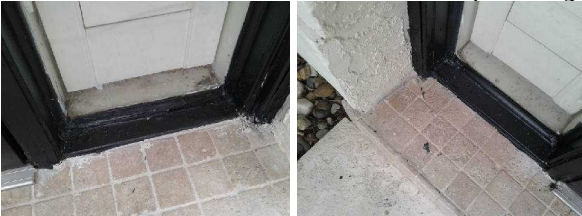
6. Entry Living Space Exterior Door: *Wood rot damage noted. Door is binding. Recommend further review/repair by a qualified licensed tradesperson.*

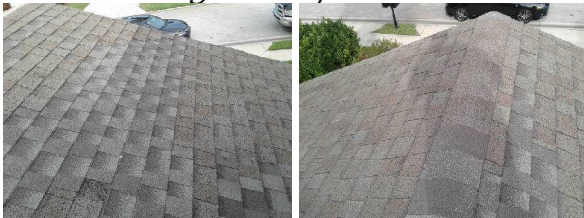
2. Main Roof Surface General Condition: *Roof materials show wear and deterioration and may be approaching the end of their useful life - Granular loss/deterioration. Dry / brittle shingles. Repairs noted.*

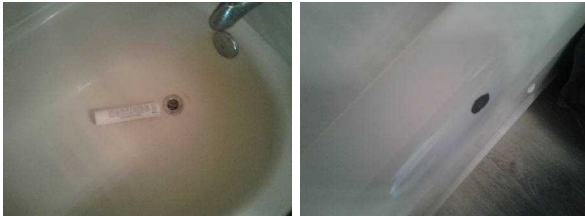
15. Guest #2 Bathroom Tub/Surround: *Missing stopper noted. Chipped tub.*

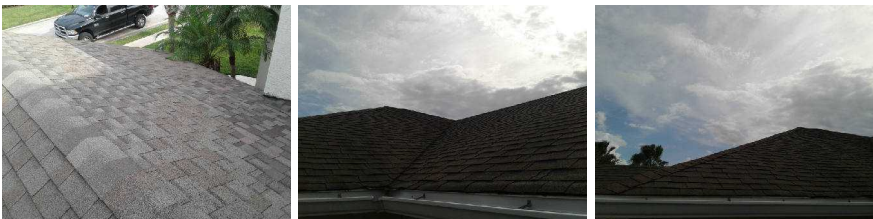
- 1. Roof Photos: *Main*

- 2. Method of Inspection: *On roof, Limited inspection upper roof*
- 3. Unable to Inspect: *Did not mount upper roof due to height of roof*
- 4. Type: *Hip, Gable*
- 5. Approximate Age: *17 years*
- 6. Material: *Asphalt shingle*

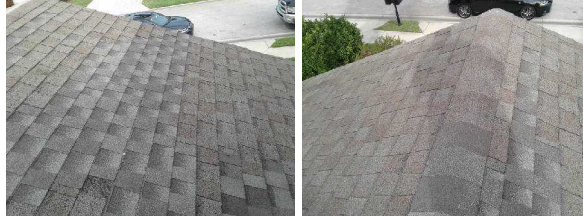
7. *Comment* General Condition: *Roof materials show wear and deterioration and may be approaching the end of their useful life - Granular loss/deterioration. Dry / brittle shingles. Repairs noted.*

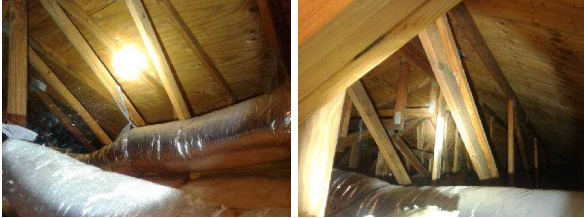
15. Access Location / Photos: *Master bedroom closet*

- 16. Method of Inspection: *In the attic*
- 17. Percent Inspected: *70% - Limited access and visibility due to clearance, obstructions and/or personal belongings*
- 18. *Acceptable* General Comments: *Attic space appeared serviceable at the time of inspection*
- 19. *Acceptable* Insulation: *Batts*
- 20. *Acceptable* Roof Framing:
- 21. *Acceptable* Sheathing:
- 22. *Acceptable* Ventilation:
- 23. *Not Present* Attic Fan:
- 24. *Not Present* House Fan:
- 25. *Acceptable* Evidence of Leaking: *None where visible and accessible.*
- 26. *Acceptable* Electrical:
- 27. *Acceptable* Plumbing Vents:
- 28. *Not Present* Firewall:

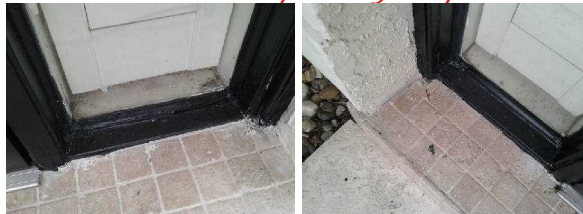
2. *Not Present* Closet:
3. *Acceptable* Ceiling:
4. *Acceptable* Walls:
5. *Acceptable* Floor:
6. *Not Present* Interior Door:
7. *Defective* Exterior Door: *Wood rot damage noted. Door is binding. Recommend further review/repair by a qualified licensed tradesperson.*

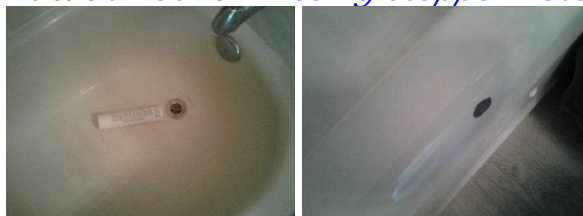
51. *Acceptable* Faucets/Traps:
52. *Comment* Tub/Surround: *Missing stopper noted. Chipped tub.*
